PRE-PURCHASE
INSPECTION

SHANDONG FU ZE

IMO Number: 9734721

INSPECTED AT SAO FRANCISCO DO SUL BRAZIL
1st SEPTEMBER 2023

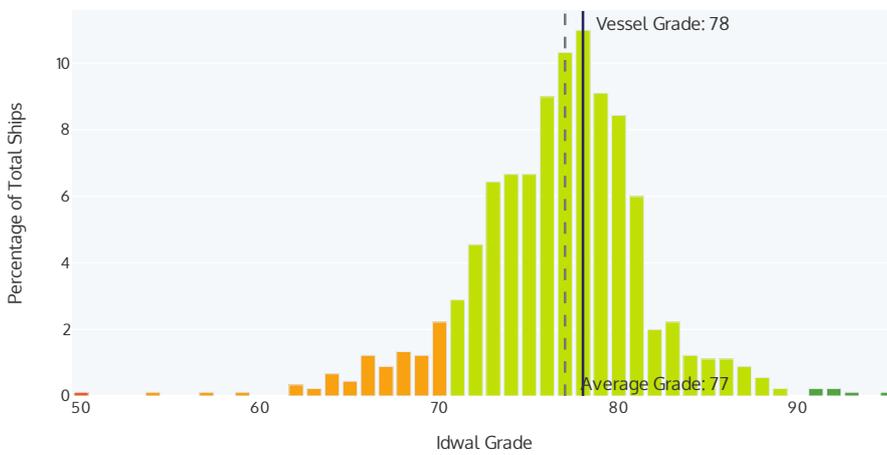
Your Idwal Grade vs other Panamax Bulk Carrier vessels

This graph shows the distribution of Idwal Grades against your ship's sector.

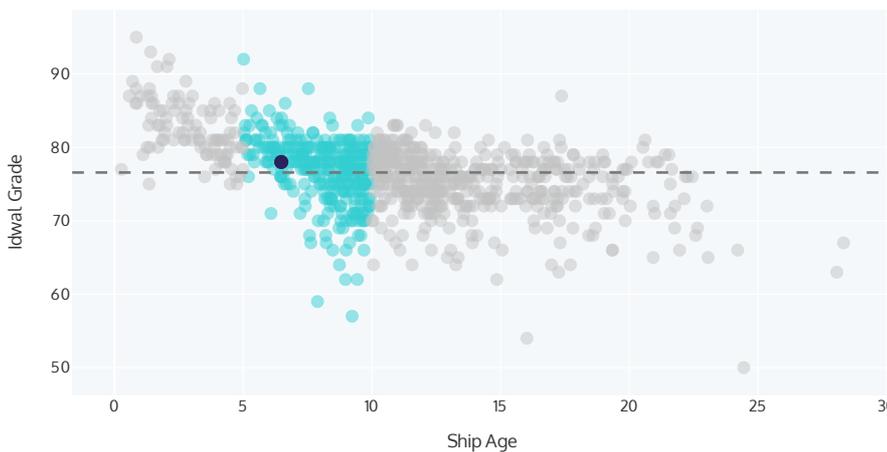
Your Idwal Grade vs other Panamax Bulk Carrier vessels, age 5-10 years

This graph shows your ship's Idwal Grade compared against other ships inspected in the same sector, within a similar age range, and how it compares against the average Idwal Grade for the sector.
